## *Englesby Brook*

### Watershed Description

### Waterbody Facts (VT05-10)

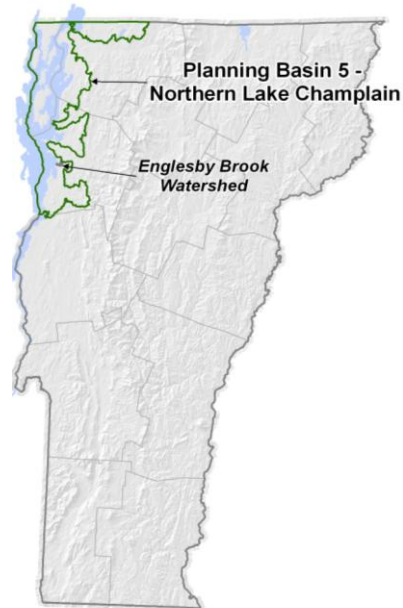
- **Towns:** Burlington
- **Impaired Segment Location:** Entire stream length
- **Impaired Segment Length:** 1.4 miles
- **Classification:** Class B
- **Watershed Area:** 0.6 square miles
- **Planning Basin:** 5 – Northern Lake Champlain

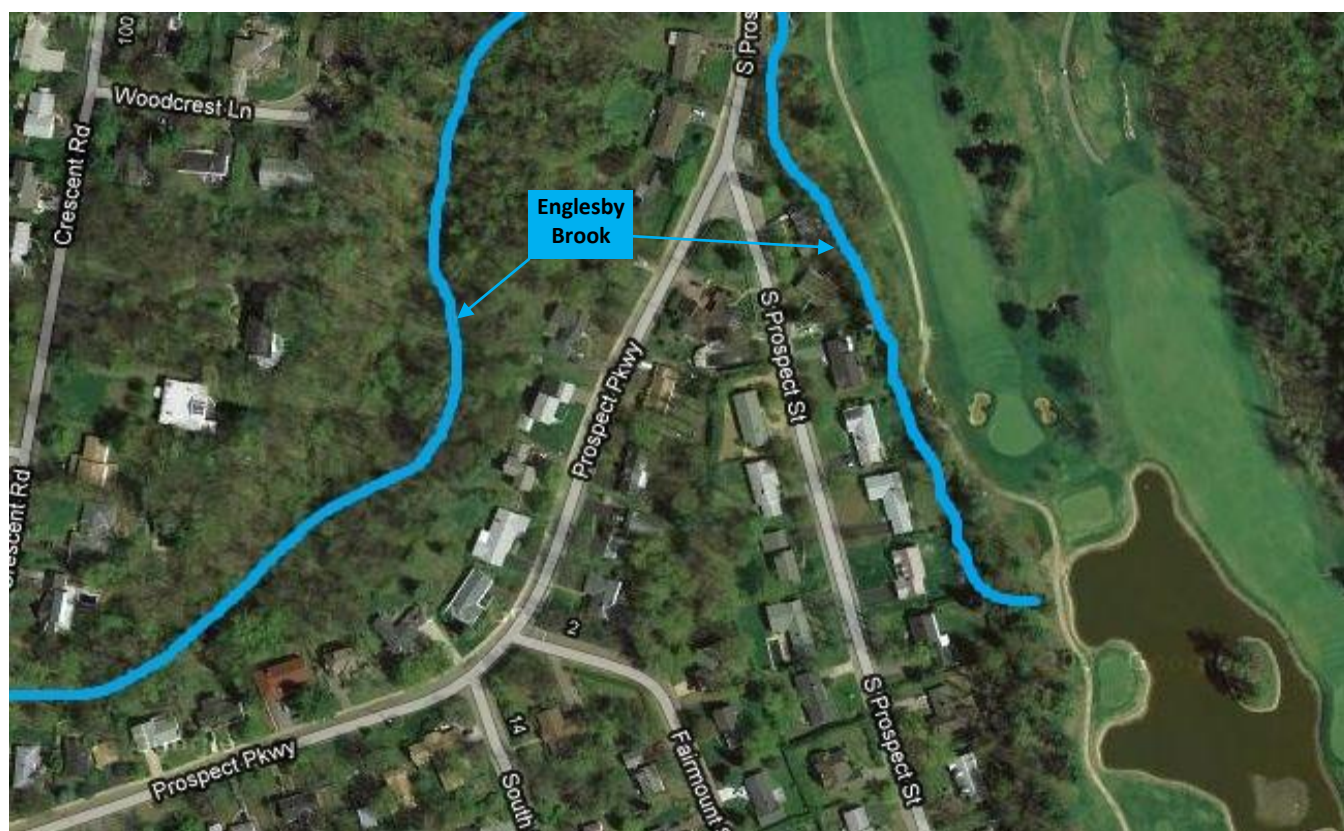
**Figure 3: Aerial view of Englesby Brook near its headwaters within the Burlington Country Club (Source: Google Maps).**

Figure 3 provides a more detailed aerial view of Englesby Brook near its headwaters. The stream leaves the golf course impoundment pictured above before it flows west through dense residential development. The primary type of development within the watershed is single family residential with other significant development types being commercial development along the Shelburne Road corridor with some industrial areas located in the lower portion of the watershed (Englesby, 2007). Englesby Brook receives a stormwater runoff from these developed areas.

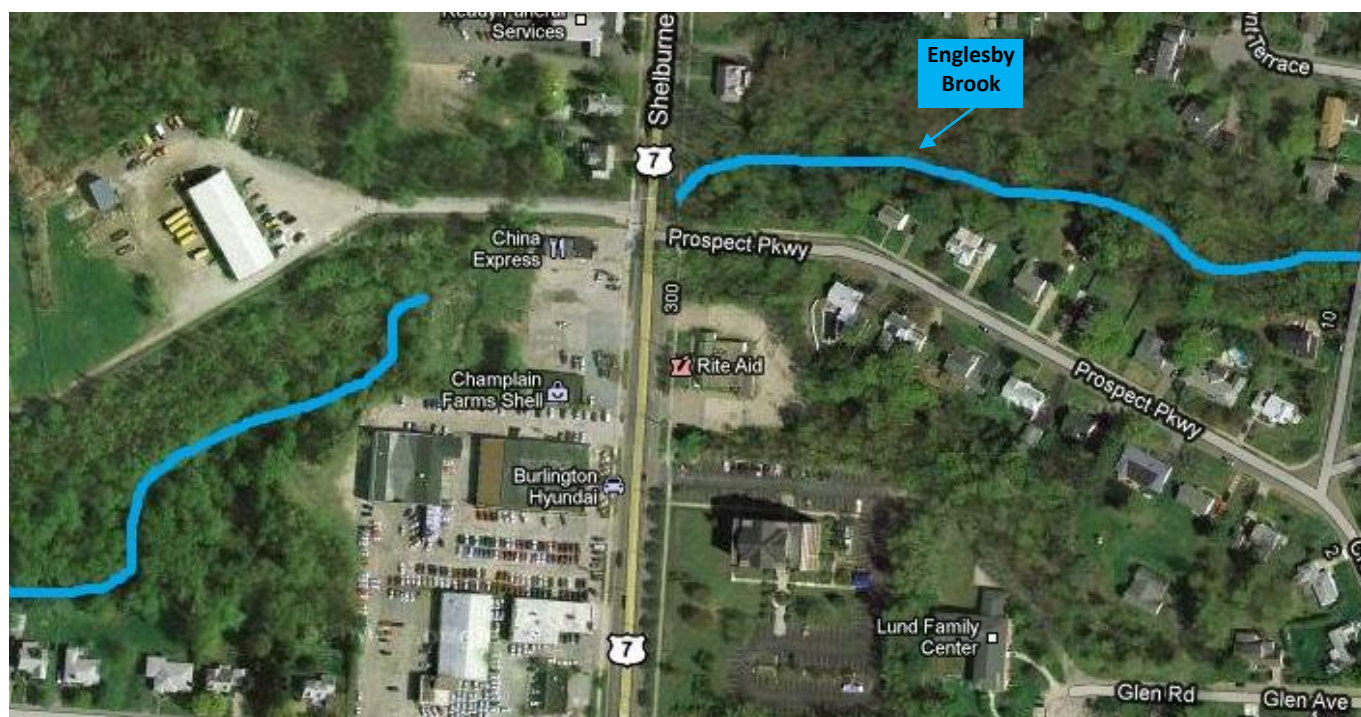
**Figure 4: Aerial view of Englesby Brook near some commercial development along the Shelburne Road Corridor (Source: Google Maps)**
